SITE INSPECTION REPORT  
FOR  
KANKAKEE AIRPORT  
KANKAKEE, IL  
ILD 980993588  
F05-8702-169  
PAN FIL0475SI

MARCH 26, 1987

DATE      March 17, 1987  
TO      File  
FROM      P Smith  
SUBJECT      Illinois/F05-8702-169/IL0475SI Kankakee/Kankakee Airport  
(Crop Dusting Facilities)  
ILD980993588

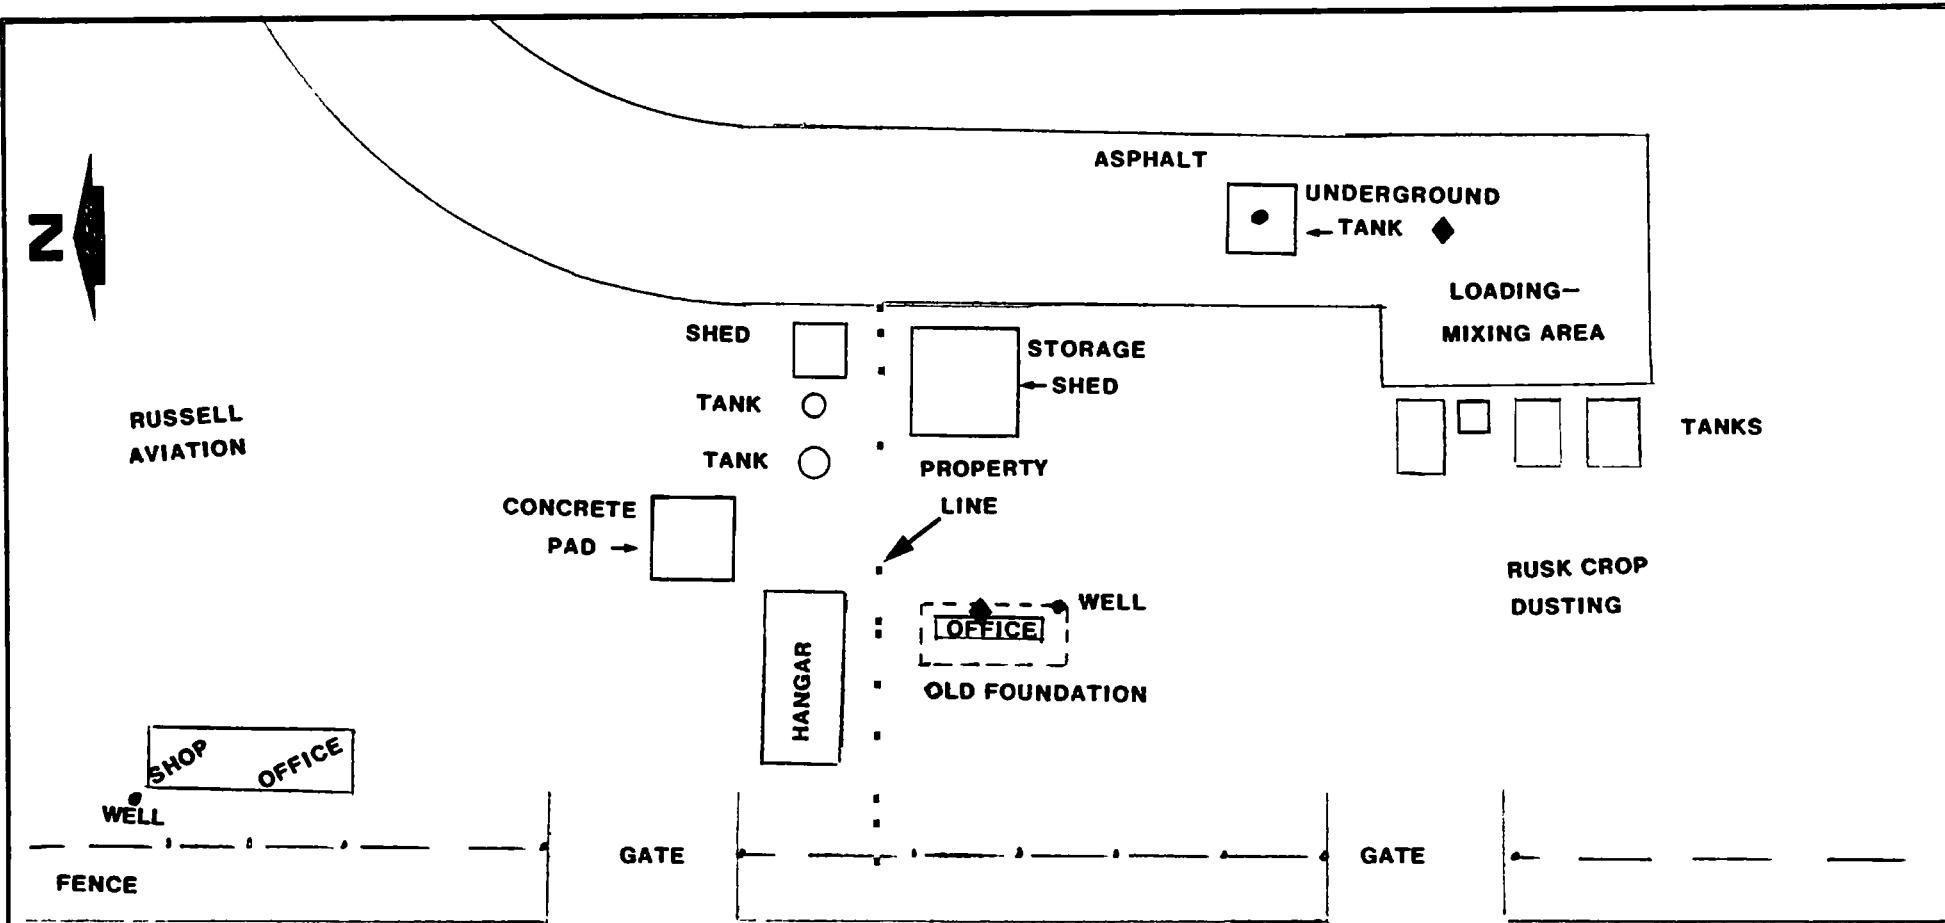
In 1984, the Illinois EPA obtained soil samples from the grounds of the Rusk and Russell operations. Pesticides, herbicides, and solvents were detected in soils beneath Rusk's landing area and inside the old farmhouse foundation.

◆ SAMPLE POINTS SHOWING CONTAMINATION

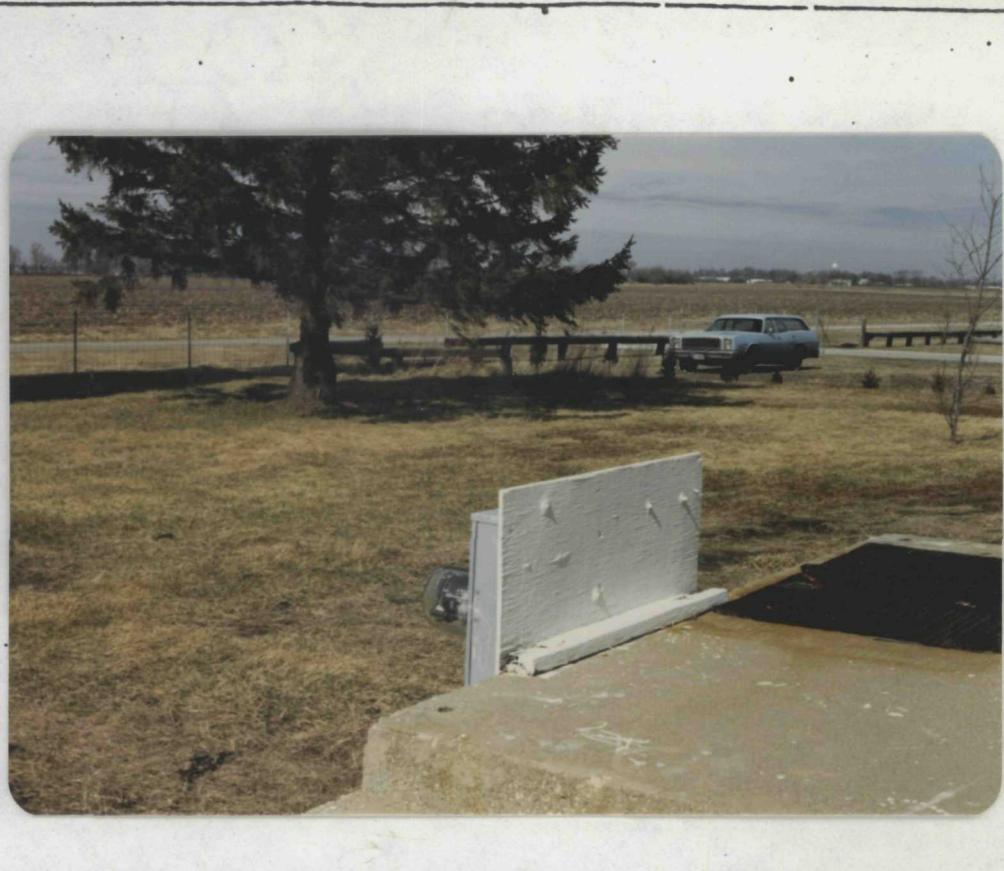
The Rusk and Russell businesses occupy adjacent lots on an old farmstead located just west of the airport runways. They have been there since 1975 and 1979, respectively. The old farmhouse foundation is filled in but is alleged to have been a repository for pesticide waste from the old Rusk tank prior to 1975. A small office now rests over part of the foundation. The other part is sodded.

It is alleged that prior to 1975, pesticide wastes from the Rusk Crop Dusting underground tank were dumped into the old farmhouse foundation.

DESCRIPTION: location of former farm house foundation.DATE 3/4/87TIME 1:30 A.M. P.M.DIRECTION: N NNE NE ENE  
E ESE SE SSE  
S SSW SW WSW  
W WNW NW NNWWEATHER partly sunny,  
40°F, South breezeSITE Kankakee AirportTDD# F05-8702-169

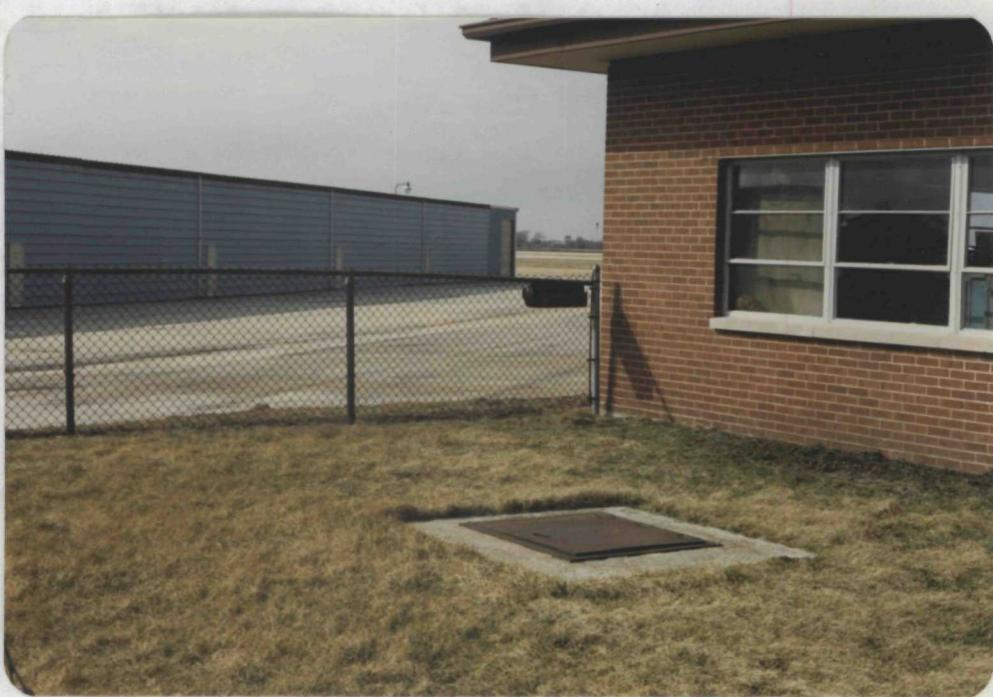
Another underground tank is located directly north of the first tank, adjacent to the Rusk maintenance shop. It was installed in 1961 to store fuel oil. It is currently used as a catch basin for waste solvent from an engine parts cleaning system.

DESCRIPTION: Location of underground solvent tank used by Rusk Aviation. In background is the blue airplane hanger under which the old pesticide tank is said to remain.

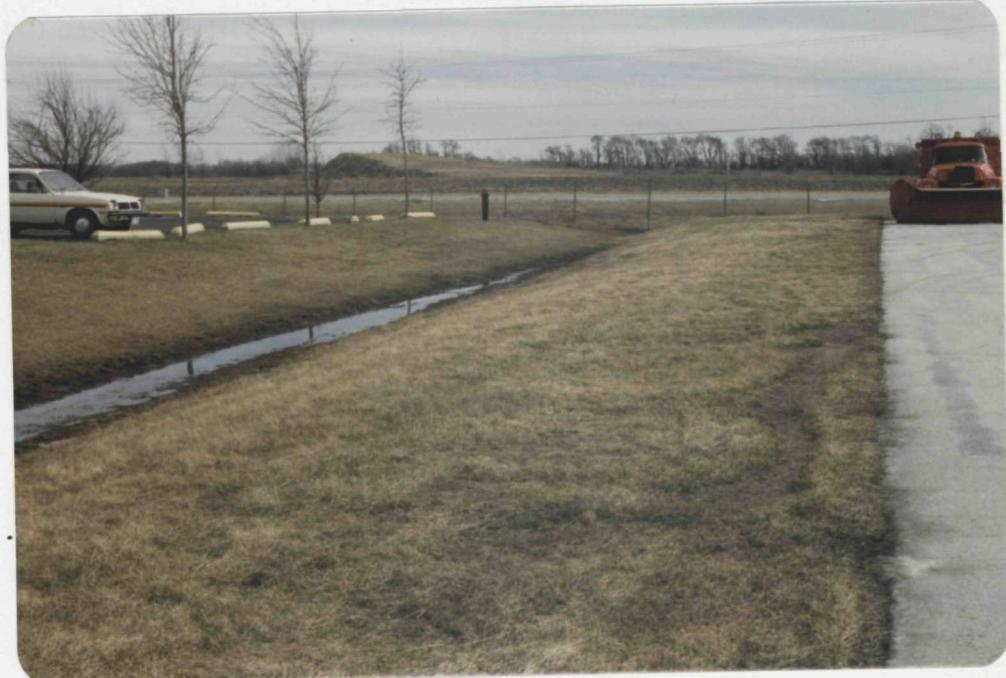
DESCRIPTION: immediately adjacent to photo below.DATE 3/4/87TIME 1:15 A.M. P.M.

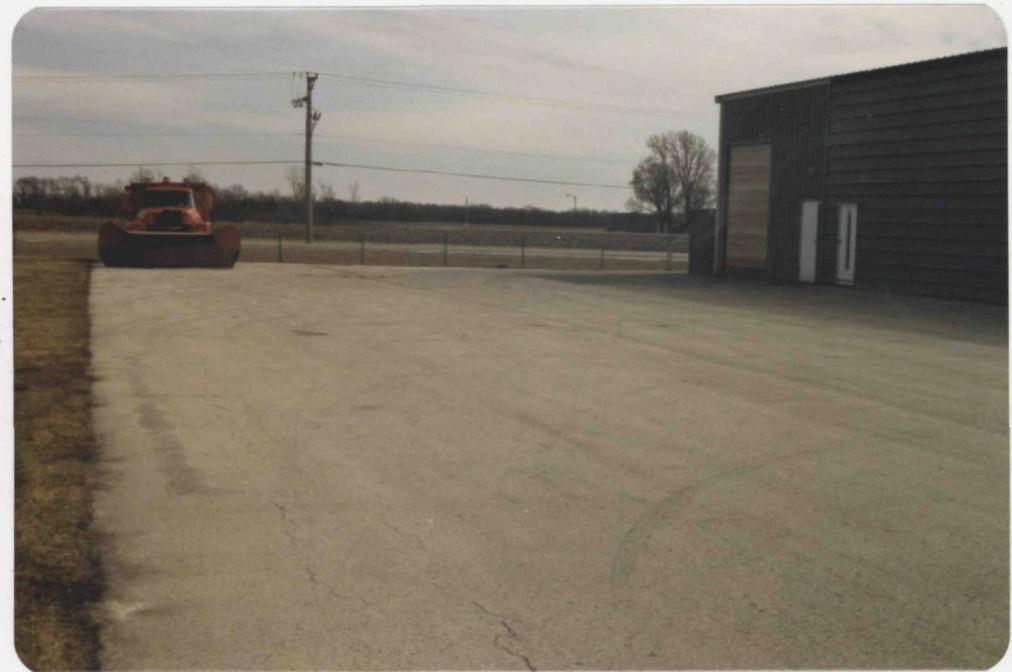
Benoit Crop Spraying operated from 1980 until 1984, when it was forced from the airport by the airport authority. The company had been washing engine cleaning fluids into the soil. Benoit was located about 500 feet south of the Rusk maintenance shop.

DESCRIPTION: Former site of Benoit Crop Spraying business.

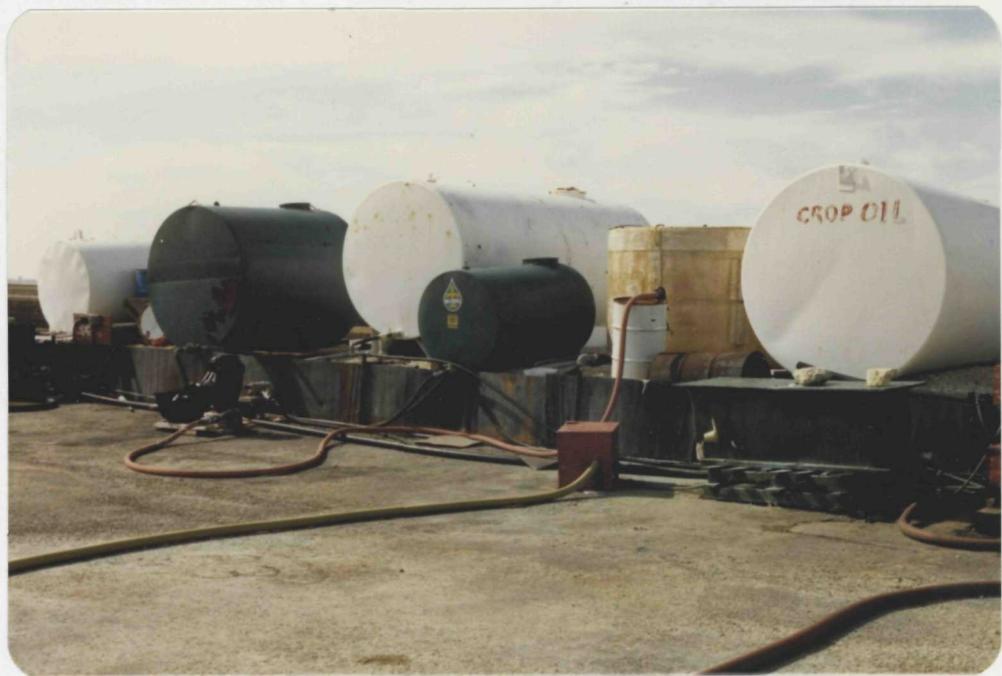
O2 DESCRIPTION OF DRUMS DIKING LINERS BARRIERS ETC Containment of pesticide wastes around the mixing / loading area is moderately adequate. Both businesses load and mix on either a concrete or asphalt pad. The buried tanks potentially leak into the soil zone where no containment structures exist. Any pesticide wastes discharged to the house foundation would be poorly contained since no liner exists, and foundation material has questionable containment value.

DESCRIPTION: Rusk Crop Dusting mixing / loading area.DATE 3/4/87TIME 11:35 A.M. P.M.DIRECTION: N NNE NE ENE  
E ESE SE SSE  
S SSW SW WSW  
W WNW NW NNWWEATHER partly sunny  
40°F, south breezeSITE Kankakee AirportTDD# F05-8702-169

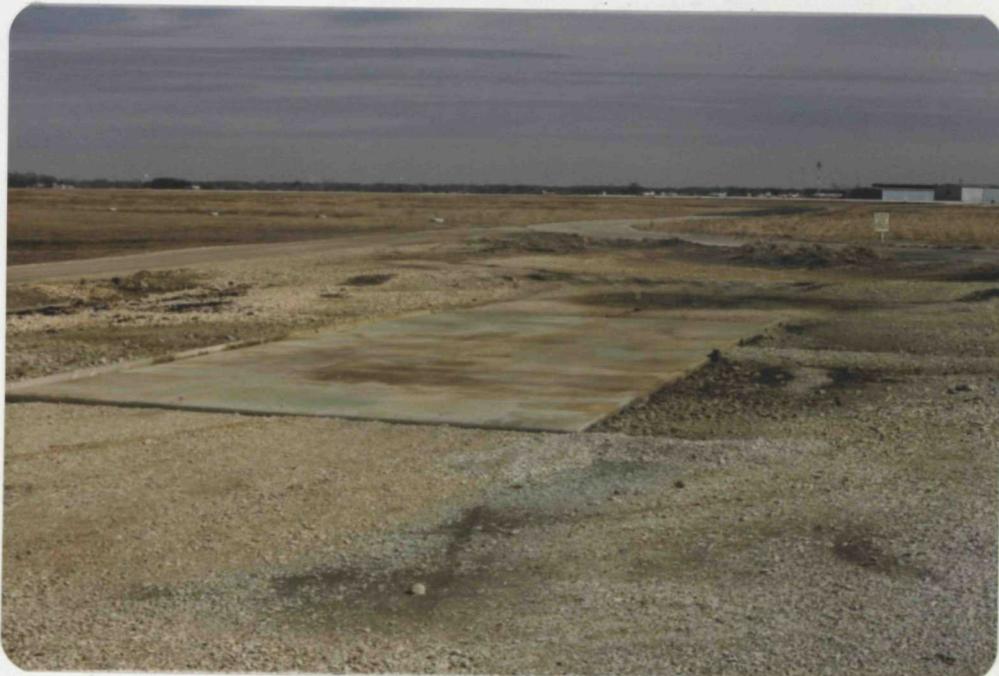
DESCRIPTION: Concrete pad on which Russell Aviation loads pesticides onto airplaneDATE 3/4/87TIME 12:45 A.M. P.M.

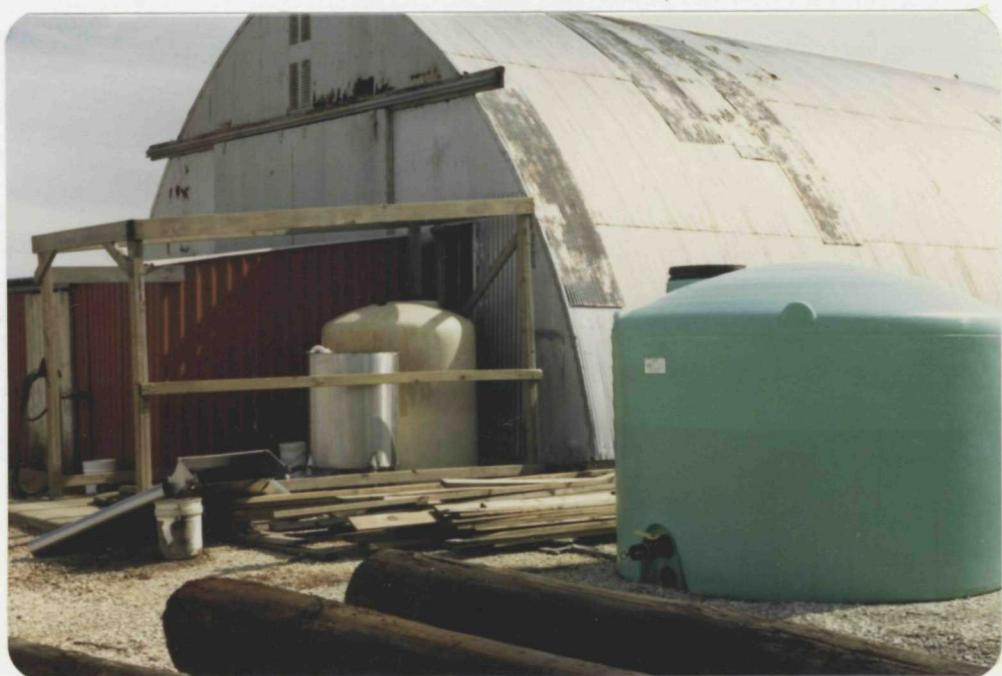
DESCRIPTION: Against background of Rusk storage building, (l to r), is Russell's red storage shed, water tank, and green plant feed tank.
